# Storm Impacts Research: Using SENCER-Model Courses to Address Policy

## Abstract

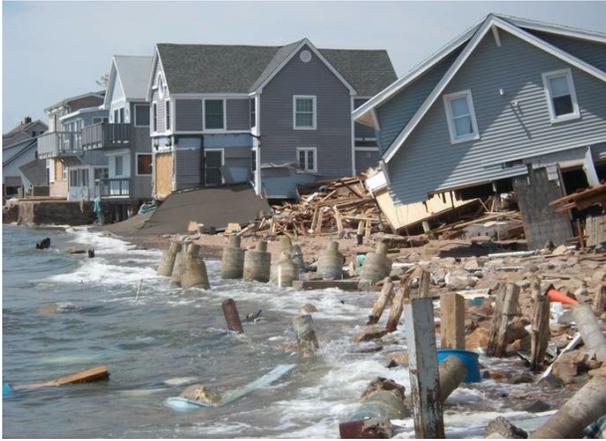
**FIGURE 2.** Cosey Beach. (Photo courtesy of the Connecticut Department of Energy & Environmental Protection.)

after a spring low tide, resulting in a storm tide of 8.9 ft (2.7 m) relative to mean sea level, just 7.9 in (20 cm) higher than Irene. If not for these factors, the storm surge would have been higher and would have occurred nearer to a spring high tide, as was previously anticipated. Nevertheless, storm surge inundation, high winds and storm waves caused considerable damage (Figure 2).

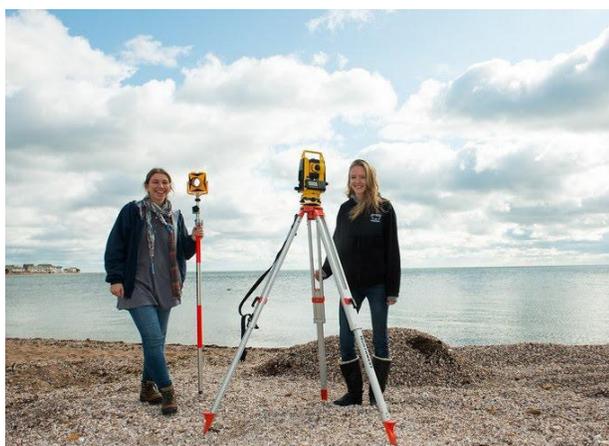
**FIGURE 3.** Data collection using laser-based surveying technology. (Photo courtesy of Isabel Chenowet.)

the upper boundaries of the debris line. These point locations were then recorded using GPS and their elevations were measured using laser-based surveying technology (total station) (Figure 3). An average elevation for the flood line point locations was then calculated along with a measure of variability (standard deviation). The average elevation for the flood debris was then compared with the peak storm surge water elevation measured at the nearby (~ 4 km) New Haven, CT tide gauge. The difference between the tide gauge elevation and the elevation determined by averaging debris elevations was just 1.5 cm, allowing a high level of confidence in the data collected.

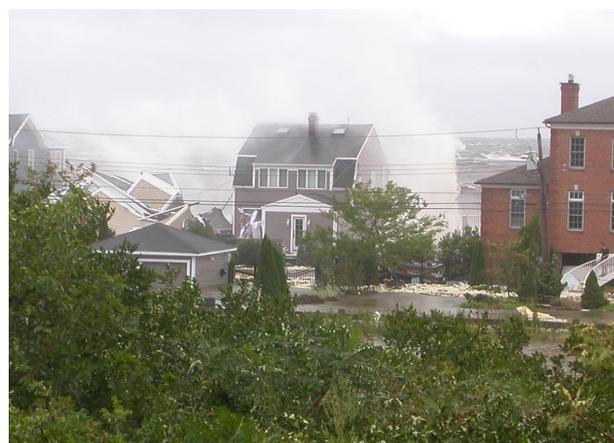
**FIGURE 4.** Cosey Beach during Hurricane Irene. Note collapsing house on left and wave splash overtopping house in center. (Photo courtesy of James Tait.)

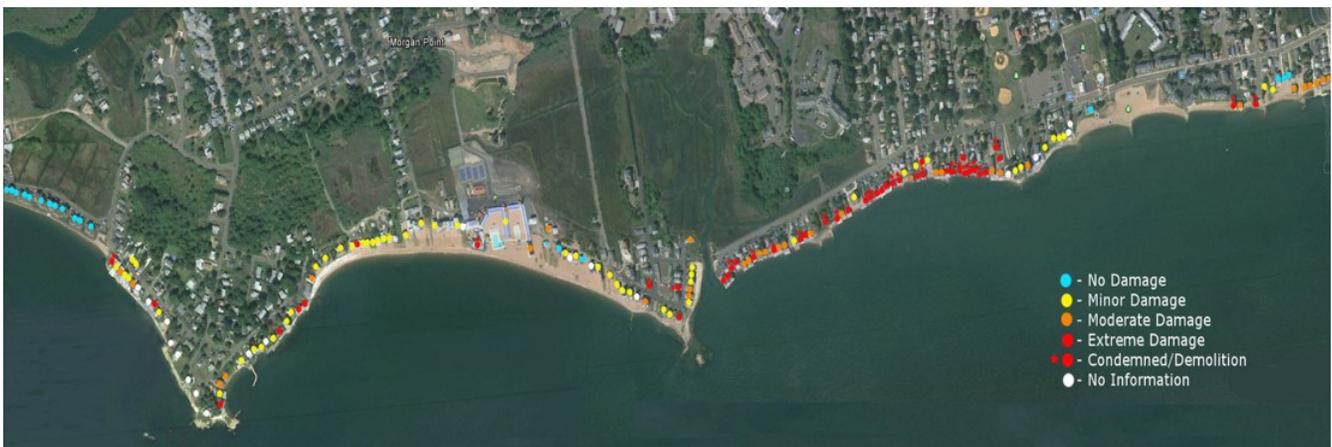
**FIGURE 6.** Damage assessment map. (Figure courtesy of Stephanie Cherry.)

In addition to empirical quantitative research, one student conducted door-to-door interviews at each house along the East Haven coastline to determine the nature of wave damage to each structure. A set of questions was asked at each home including the cost of structural damage that occurred, what type of damages occurred, whether or not a sea wall was present, and whether or not the structures were raised at the time. A map was created using Google Earth to show the structural damages pattern. Structures were put into one of the following categories: severe damages requiring demolition, severe damages, moderate damages, minor damages, and no damages.

While the presence of seawalls and raised structures all influenced the degree of wave damage, they were not the primary determinants. For structures that were raised, elevation on pilings often proved effective. However, in some cases, the magnitude of elevation was insufficient relative to peak surge elevation. In other cases, minor damages occurred to fences or stairs to elevated decks. In general, however, few structures were elevated before Sandy. Seawalls were frequently overtopped, deflected energy onto adjacent structures, or increased the elevation of wave splash (Figure 4). When the coastal road elevation maps (Figure 5), the damage assessment map (Figure 6), and beach profile measurements (Figure 7) were compared, it

portion of Cosey Beach Avenue, for example, is the highest part of the road topographically. Damages here were minor to non-existent. In the western portion of Cosey Beach Avenue, houses were the most robustly built, typically had low seawalls, but were at a lower road elevation than those in the central portion, and more importantly, had no buffering beach at high tide (compare Figures 5 and 6).

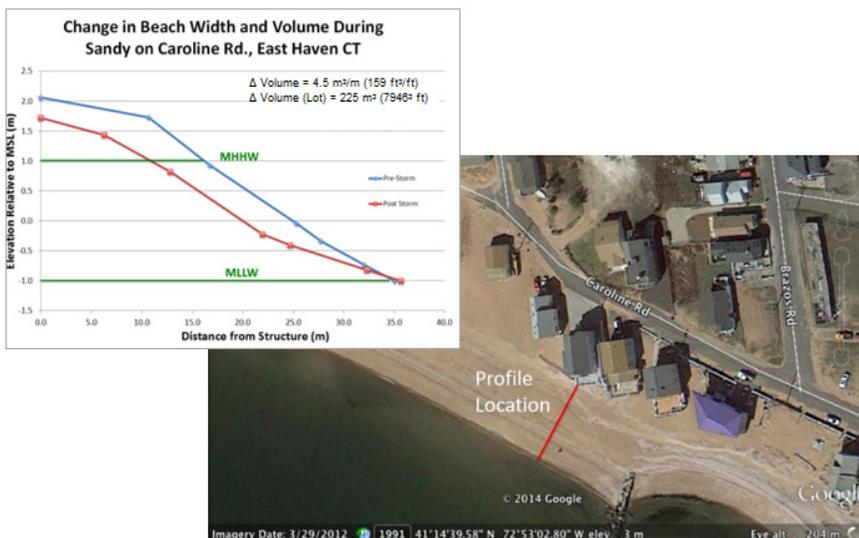
**FIGURE 7.** Changes in beach profile via volume of sand. (Figure courtesy of James Tait.)

Students also collected data on beach erosion (or stability) by measuring the difference in beach profiles over time. Profiles were measured and re-measured at fixed geographic locations. Over the past 3.5 years, beach profiles were measured along East Haven beaches to better understand longer-term erosion or accretion patterns. Where possible, profile measurements were spaced along the beach approximately 200 m apart. Profile locations were recorded and measured from the seaward-most edge of coastal structures, or from the edge of the beach, to maximum wading depth. These measurements were then

plotted using Microsoft Excel to reveal spatial patterns of erosion over time. Calculated variables included the width of the beach to the mean higher high water (MHHW) intercept and the volume of beach sand under the profile and above the mean lower low water elevation. Volumetric measurements were given units of m<sup>3</sup> per unit length of shoreline. This allowed total volume of sand calculations for specified reaches of beach.
